Site: ABC School
 Playworld - Challenger

Date of Inspection: 1/1/2019
Inspection Completion Time: 4:00 - 4:15 pm

Inspector: Recreation Today
NPSI Certification#: 00000-1234

Detailed Inspection Report

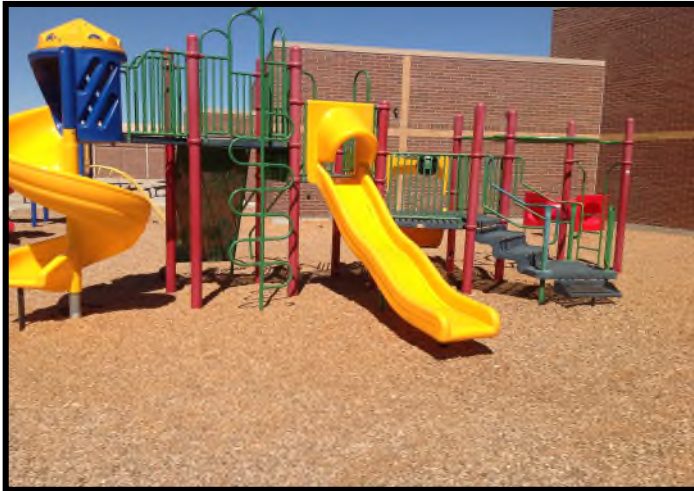
Image 1

Structure Overview:
Action taken at time of inspection:
This is a picture of the Playworld Systems structure. All bolts were checked and tightened.

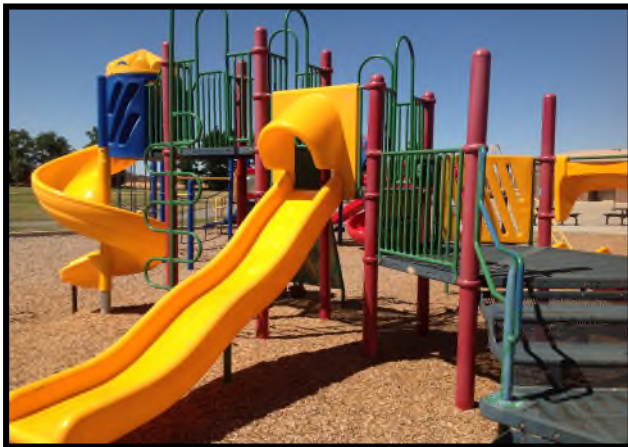
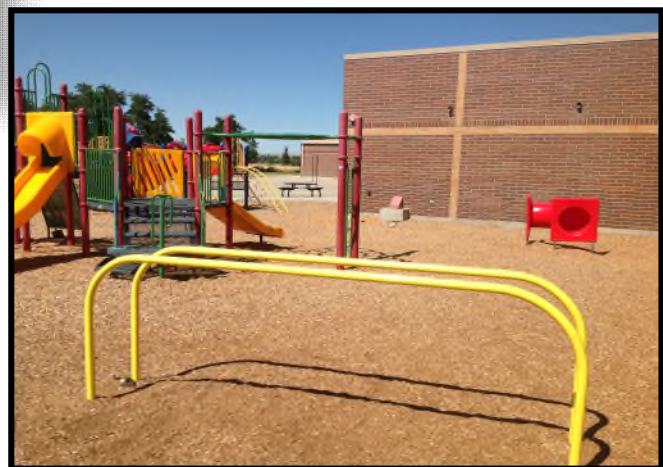
Image 2

Structure Overview (Posts):
Action taken at time of inspection:
All posts were checked and all are in "good condition". All barriers, bridges, climbers, climbing walls, handrails, platforms, slides, steps and ladders were also checked and are in "good condition".

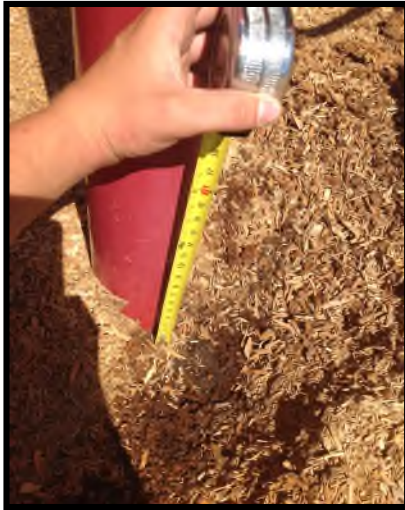
Image 3

Structure Overview (Concrete Footings):
Action taken at time of inspection:
All concrete footings have been checked and are solid and listed as "good condition".

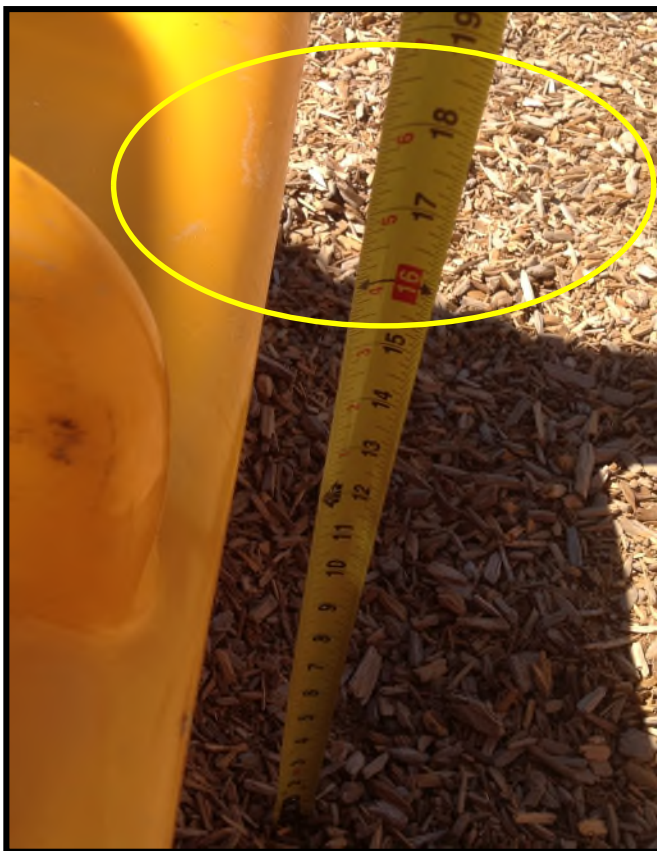
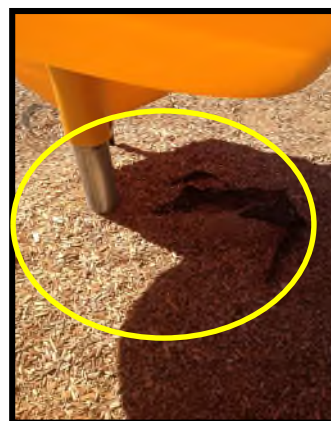
Image 4

Surfacing Overview:
Corrective action needed:
Engineered Wood Fiber (EWF) is 8" low and needs to be recapped. A total of 166 cu yds is needed to bring surfacing to a compliant level. Bottom of slide bedway to EWF should not exceed 11". There is exposed geocloth and weeds growing in fall material.

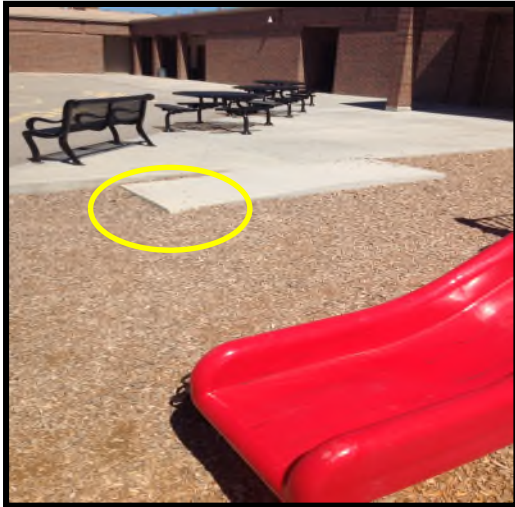
Image 5

The ADA ramp is in good condition. To make ramp compliant, please rake EWF onto end of ramp which drops onto the playground surface.

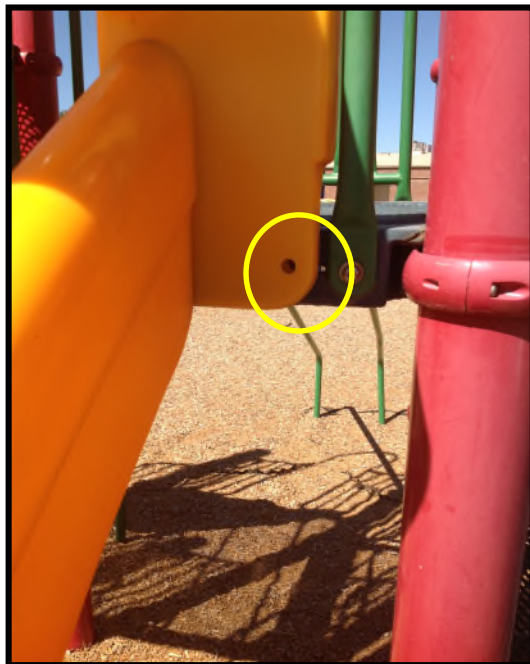
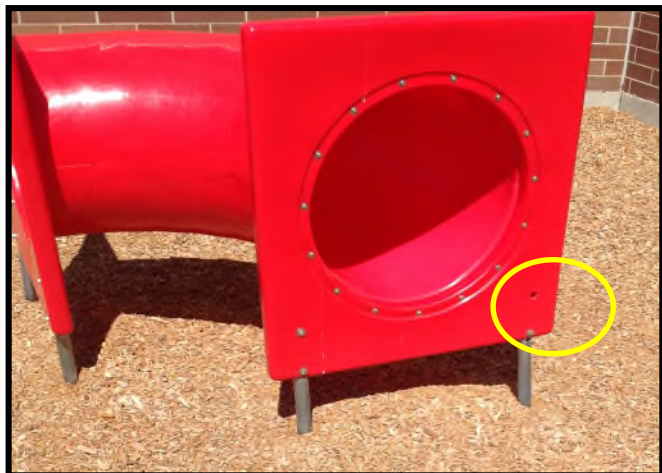
Image 6

Missing bolts on slide and crawl tube..

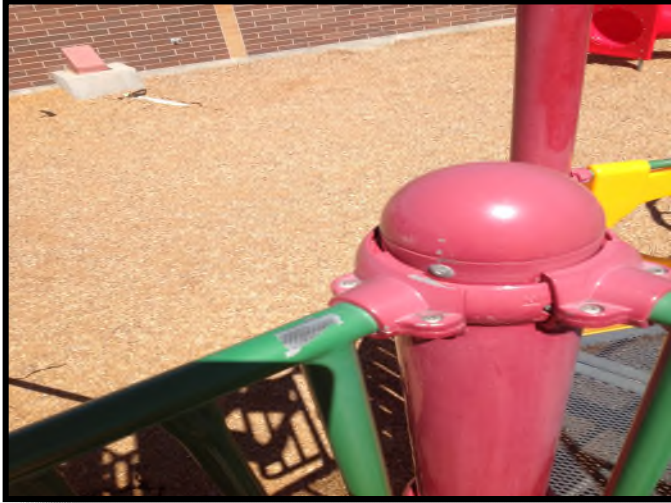
Image 7

Paint is flaking on structure.

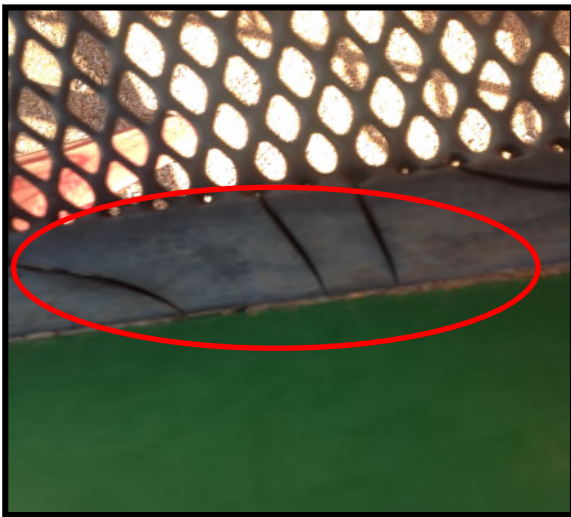
Image 8

Cracking in covering on platforms.

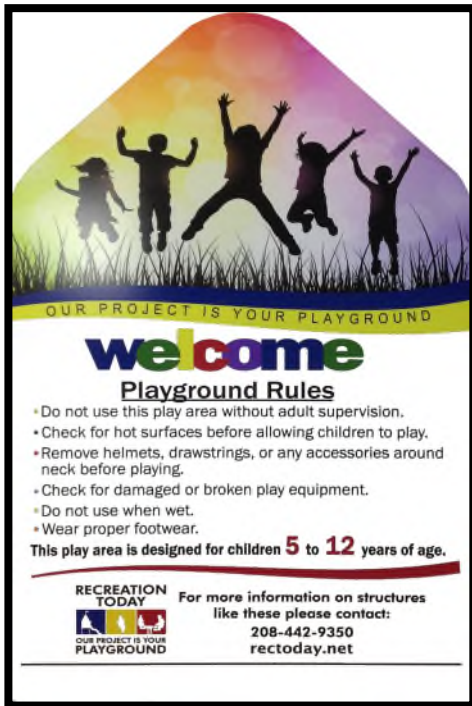
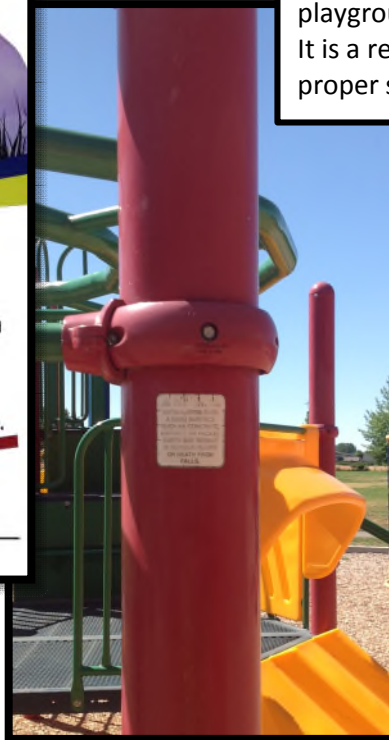
Image 9

Signage Requirements:**
Corrective action needed:
There is no Risk Management sign on the playground. Warning labels are present. It is a requirement per the CPSC Guidelines that proper signs be placed on the playground. Sign
